Module 03

Three Mile Island Accident (TMI)

Prof. Dr. H. Böck
 Vienna University of Technology / Austria
 Atomintitute
 Stadionallee 2,
 1020 Vienna, Austria
 boeck@ati.ac.at

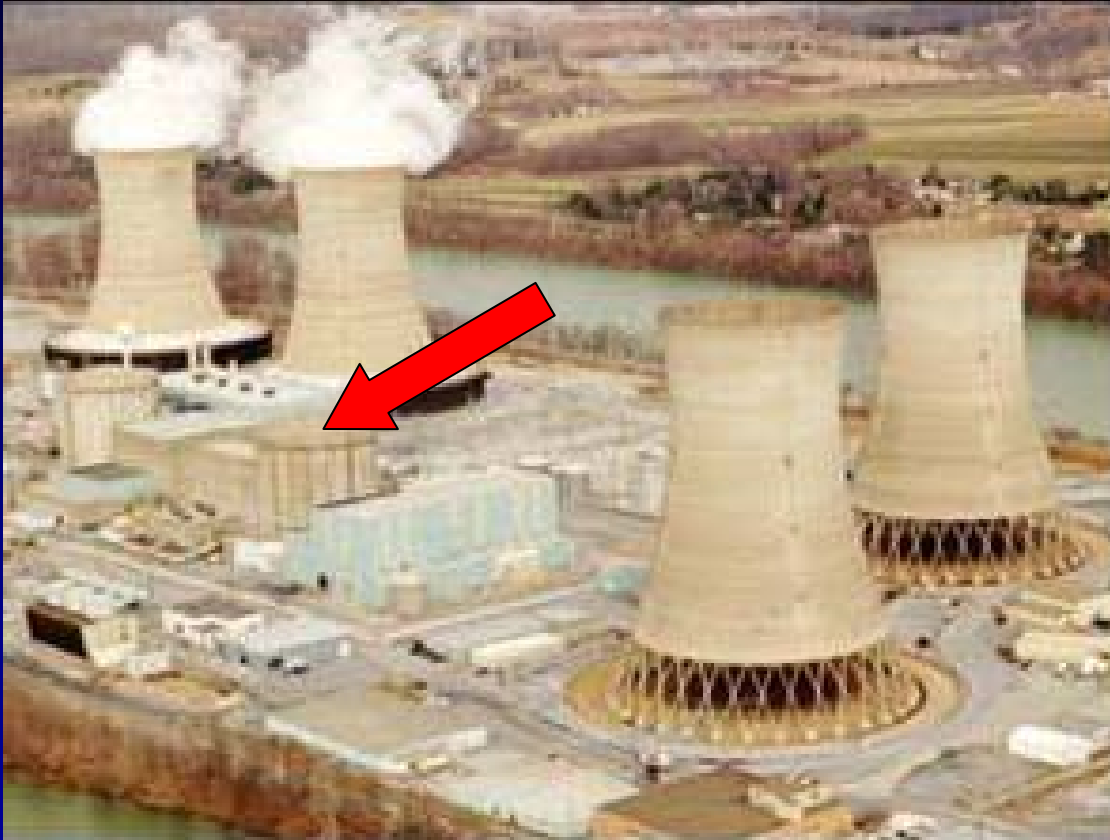
Three Mile Island

- Harrisburg/
Pennsylvania
- Two PWRs on the
Site
- TMI-2 accident:
March 28th, 1979

- TMI-1: 786 MW_e, first grid connection 11/72
- TMI-2: 880 MW_e, first grid connection 4/78

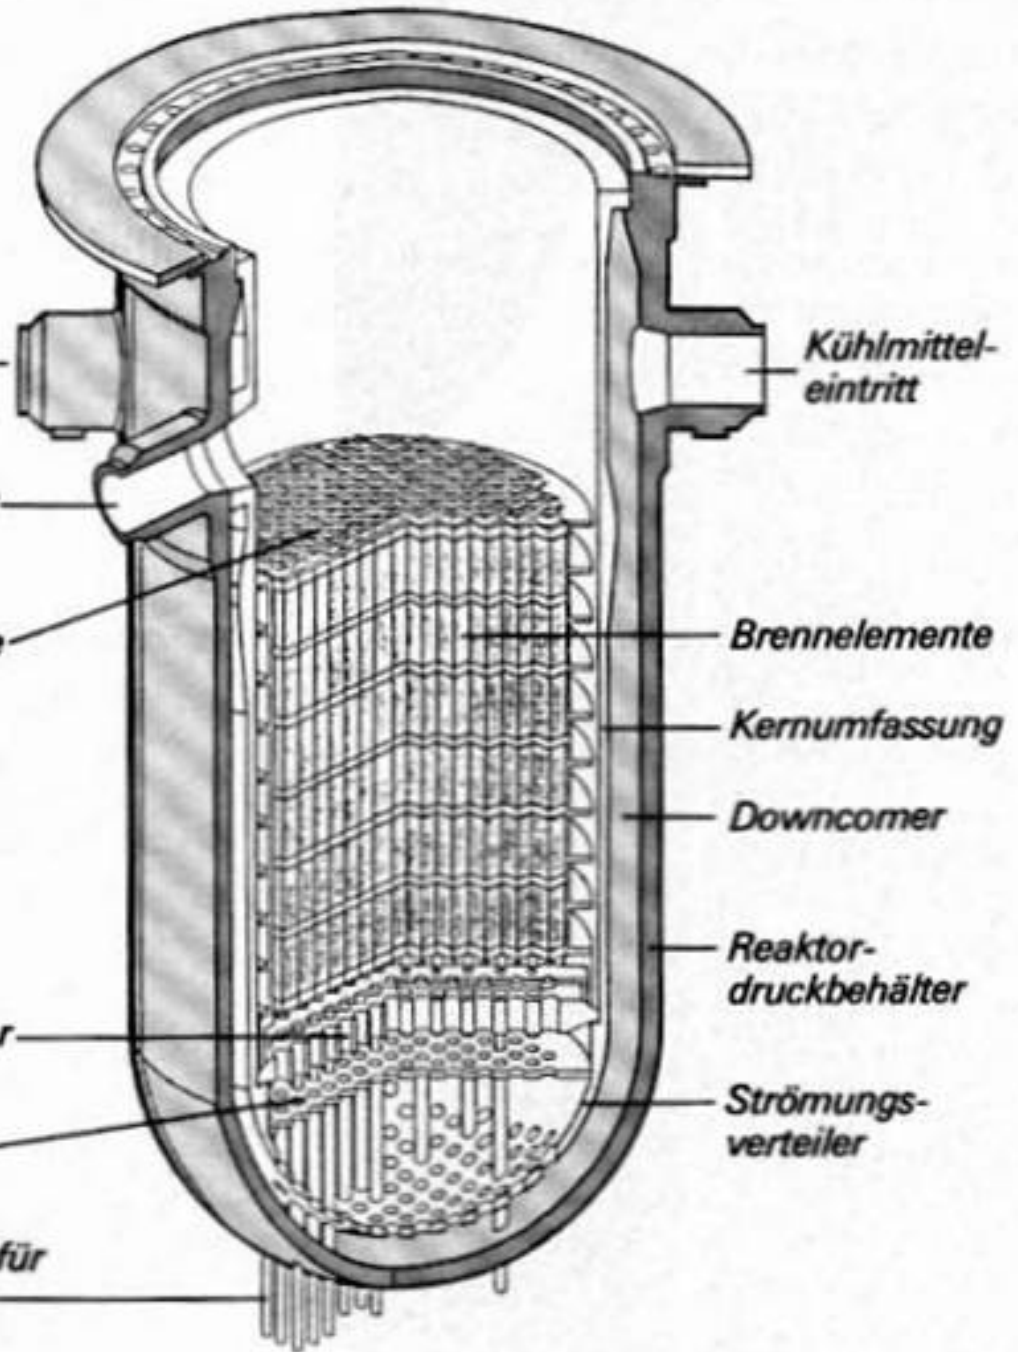
Core Melt

- 9 secs:
- Reactor was shut down immediatly by inserting control rods

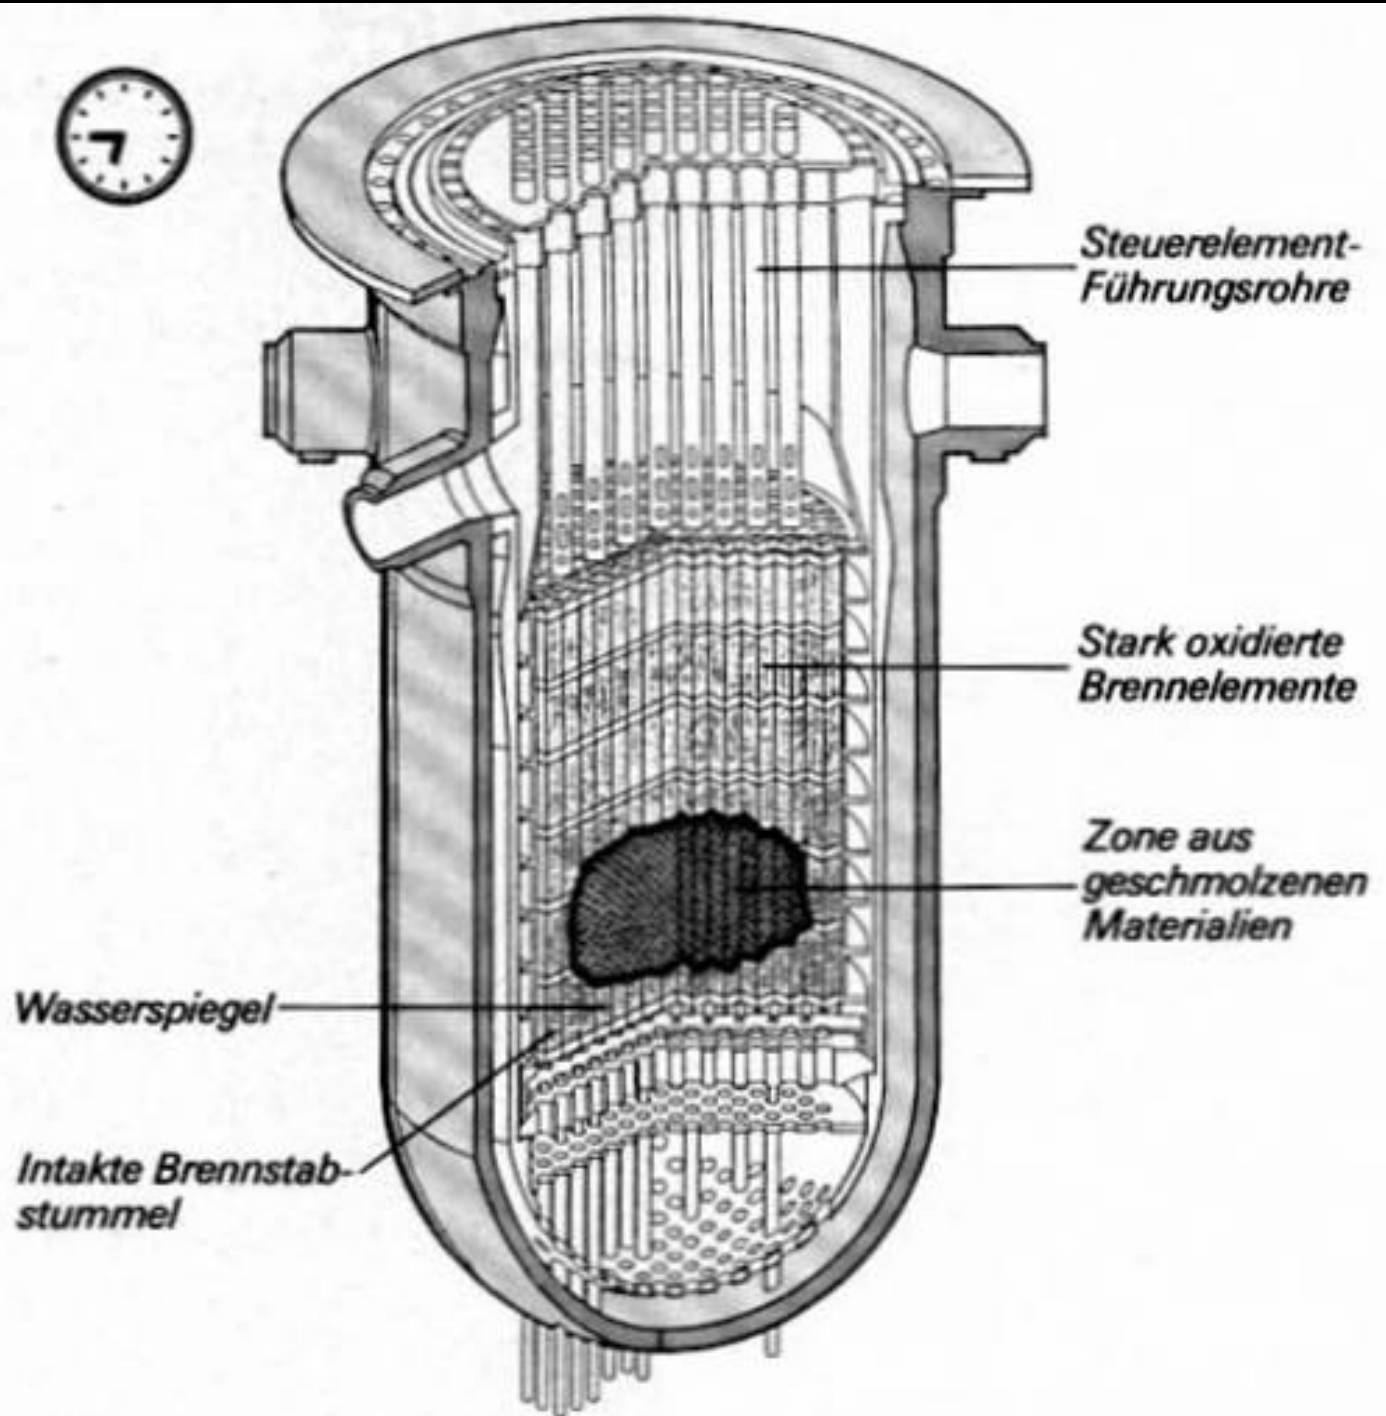
Core Melt

- About 2h45m later:
- Partial core melt due to fuel decay heat and inadequate cooling
- Additional heat production by exothermic Zircaloy-water reaction

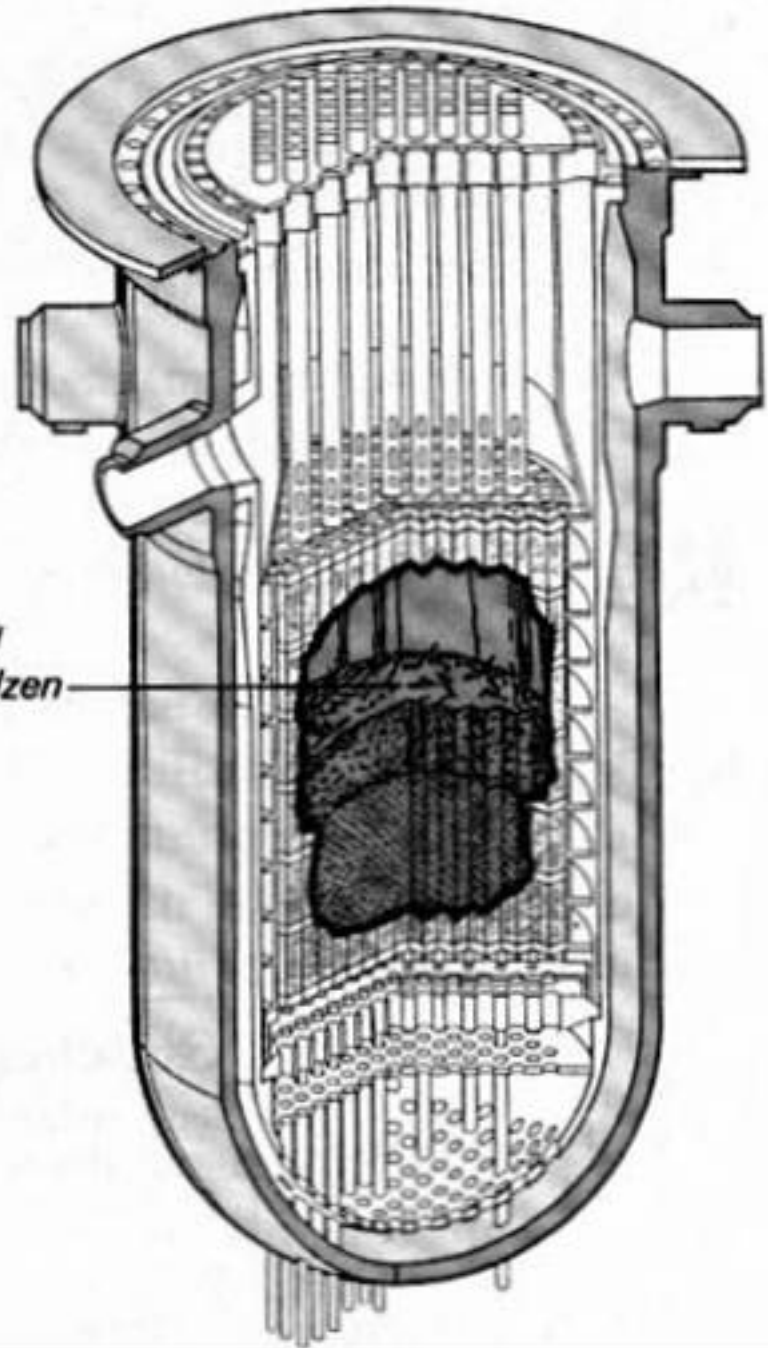
Core Melt

- About 3h later:
- Molten fuel and structural materials ultimately concentrated at the bottom of the pressure vessel
- Risk of PV damage

Schüttbett aus zerbrochenen und nach dem Schmelzen erstarrten Brennelementmaterialien

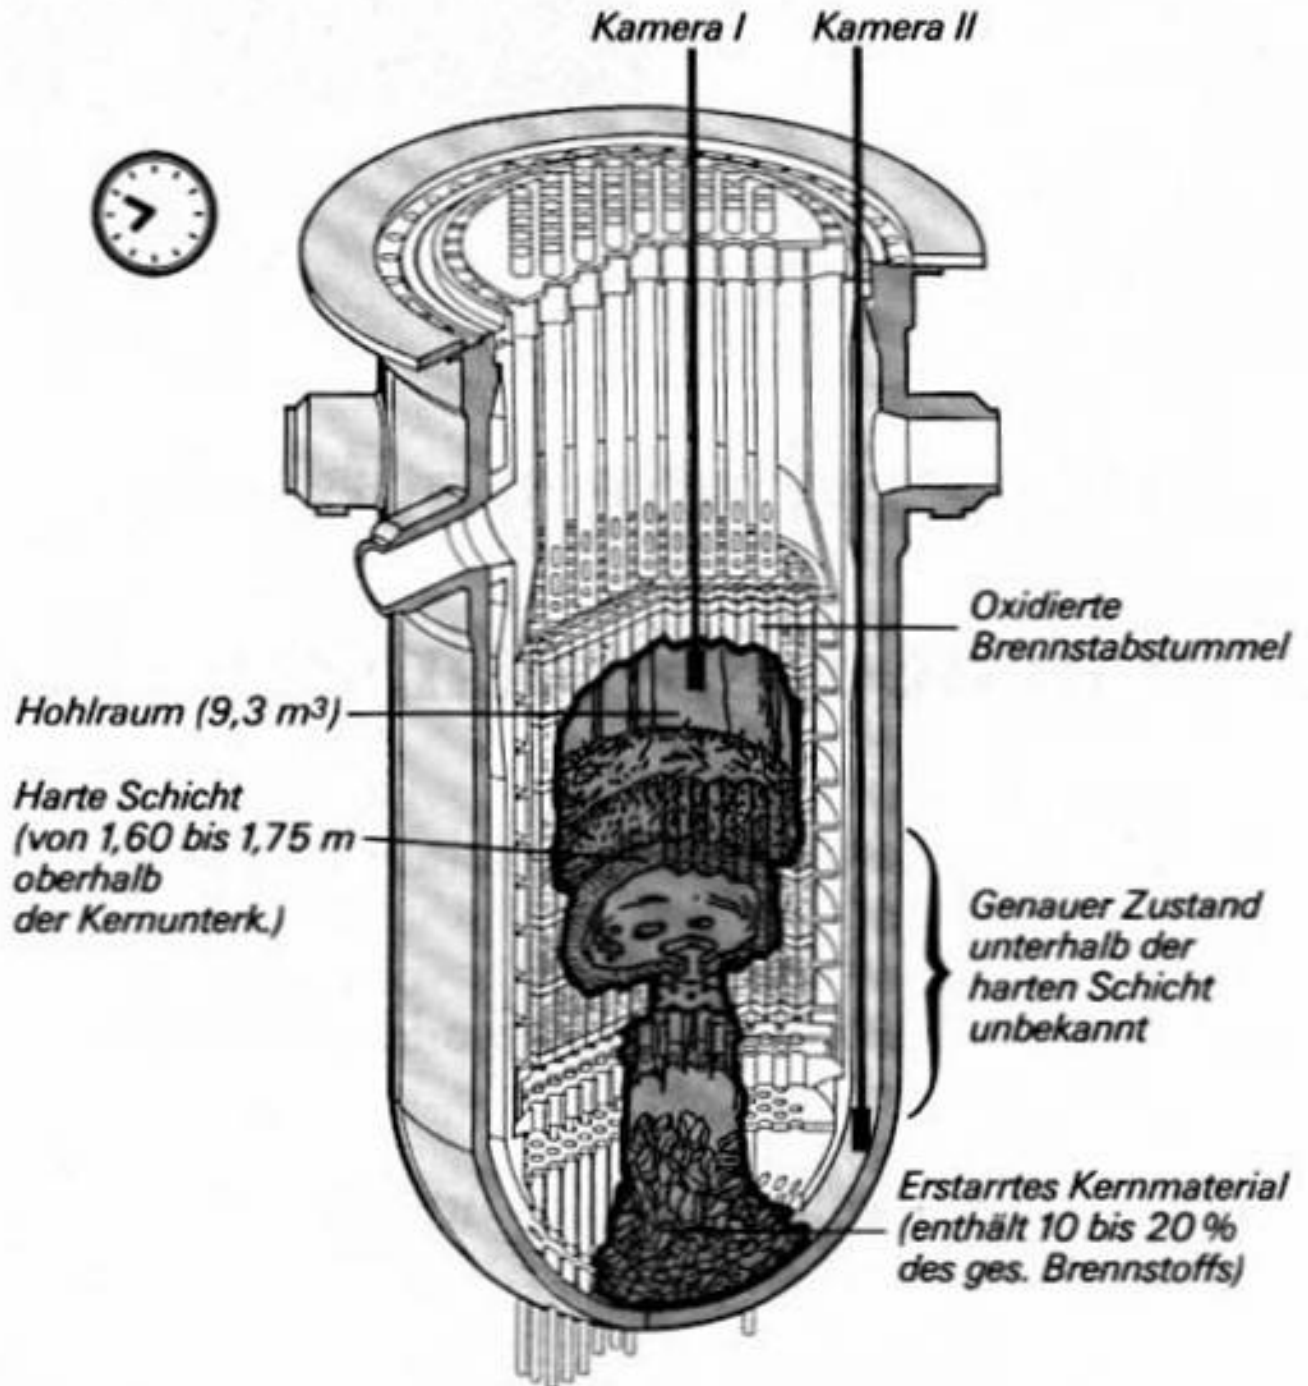
Core Melt

- About 3h50m later:
- Molten fuel and core structure material dropped to pressure vessel bottom and solidified there
- No PV damage due to a thin water layer between „Corium“ and PV material
